# Derby Market Hall - Door Accessibility Improvements Heritage Statement

DMH-LAT-XX-XX-RP-A-0110

Derby City Council  
Rev P02 - 08.09.26

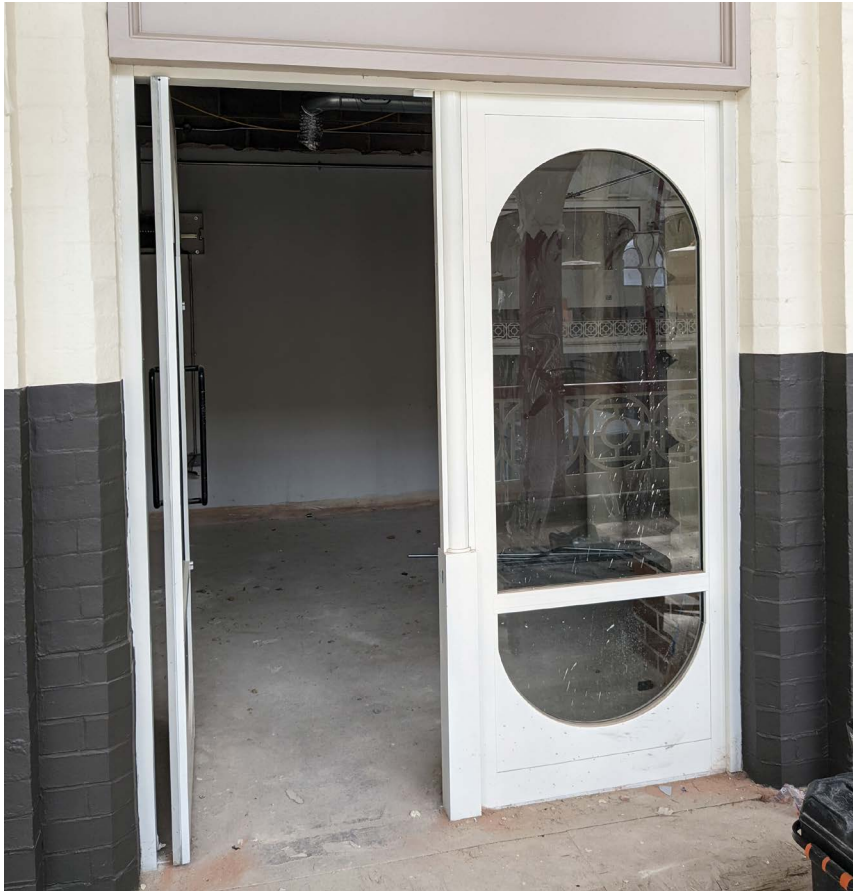
Fig. 3: Existing door - typical photo

The doors are single leaf opening doors, with a fixed side panel that closely resembles the opening door leaf. They are fabricated from aluminium with single-glazed lozenge design, and feature a fixed central decorative post, against which the opening door leaf closes.

The doors open into the retail unit, with a pivot hinge top and bottom and remain in a hold-open position at 90 degrees, controlled by a concealed floor spring, cast into the concrete floor. There are pull handles to both faces of the door, which further limits the clear opening width. Additionally, users have identified these doors as being as stiff and difficult to operate.

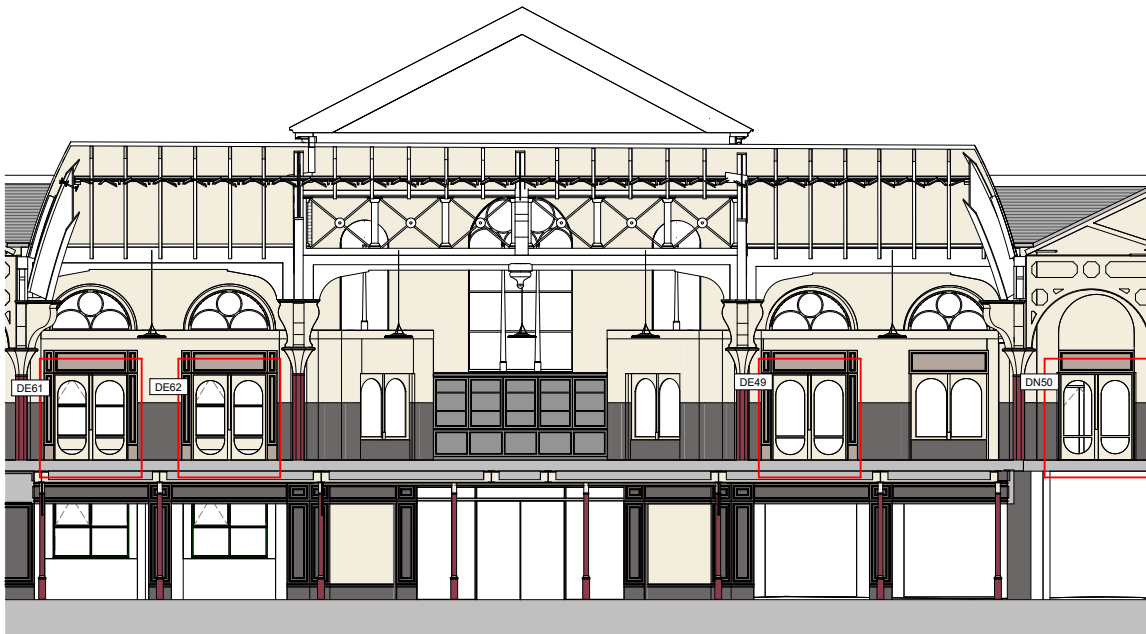
Fig. 5: Existing elevation showing internal doors along the southern balcony

Internal elevations highlighting the existing 7no. lozenge doors

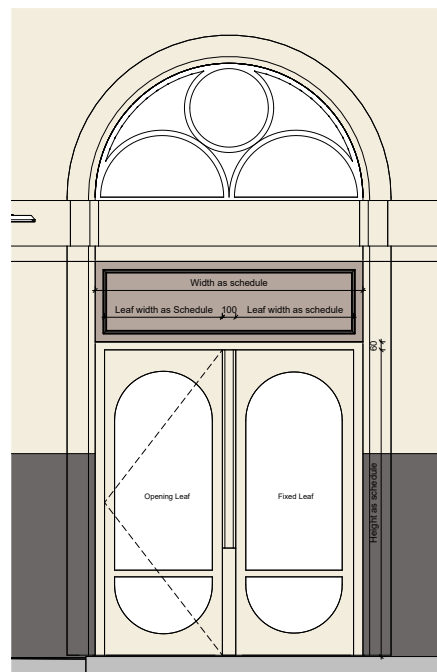
Fig. 7: Existing door option

The clear opening width of these doors is compliant with Building Regulations for existing buildings. However this width does exclude users of electric wheelchairs and mobility aids and requires manual wheelchair users to spend time aligning themselves with the opening to pass through. Significant improvement in accessibility could be provided if the clear width could be improved.

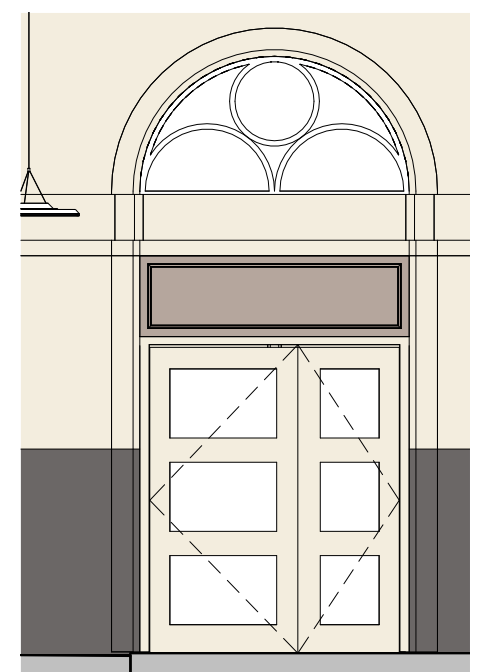
Fig. 9: New asymmetric door option

To provide a greater clear opening then new doors would need to be supplied with an asymmetric design. The design of these doors would be consistent with the design of the new doors (DN60). By installing an asymmetric doorset then the greatest clear opening (1000mm+) can be provided improving the accessibility of the units to the greatest degree with minimal additional impact on the significance beyond the replacement of the doors with a symmetrical pair of the same design.

A range of options were considered for the replacement of the existing doors, and it is felt that the current proposal to replace the doors with sympathetically designed sets of asymmetric doors which match the details used on other modern doors is the least harmful way to achieve the required improvement in accessibility to support the continued use of the Make & Trade Units.

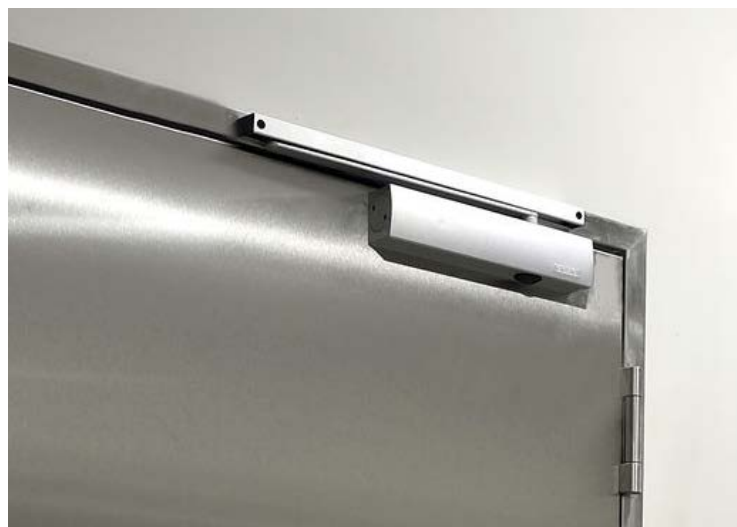
- cam-action door closer with slide channel, to reduce force required to open door
- fully electrically operated door opening
- replacement concealed floor spring.

To minimise the impact a mechanical cam assisted closer would be minimally intrusive whilst still providing the necessary reduction in opening force. This device could also incorporate a mechanical hold open to minimise visual clutter whilst still providing the necessary functionality

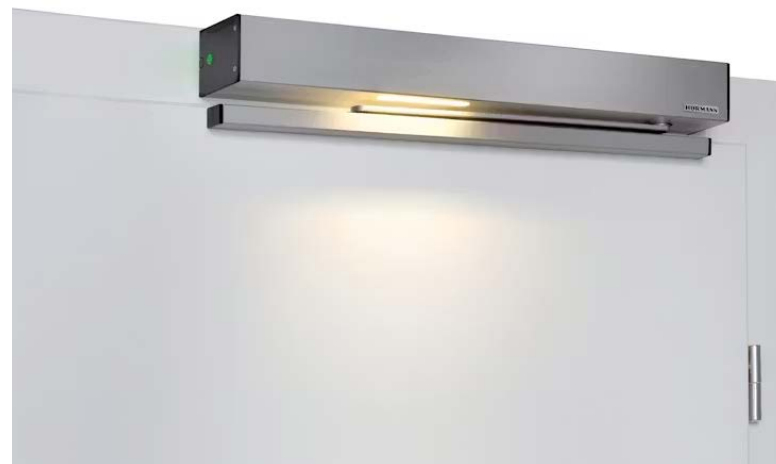
If the weight of the door requires excessive force to open it, then an EasyAssist low-energy door closer with amplified motor transmission could augment the force applied by the user to assist in its ease of opening.

This is an electrically operated closer that is activated by the force applied by the user, and accelerated by the motor, thereby requiring less effort by the user to open the door.

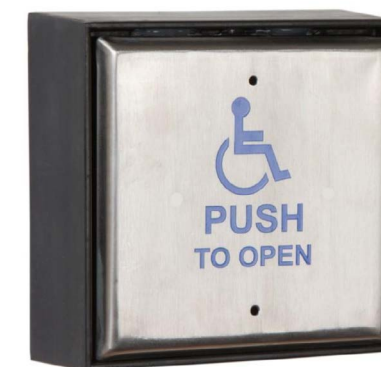
To provide a fully automatic door opening solution then push buttons would need to be mounted both inside and outside of each retail unit. This would required two surface mounted buttons (as per the below examples), and surface-mounted conduit to provide the power supply.

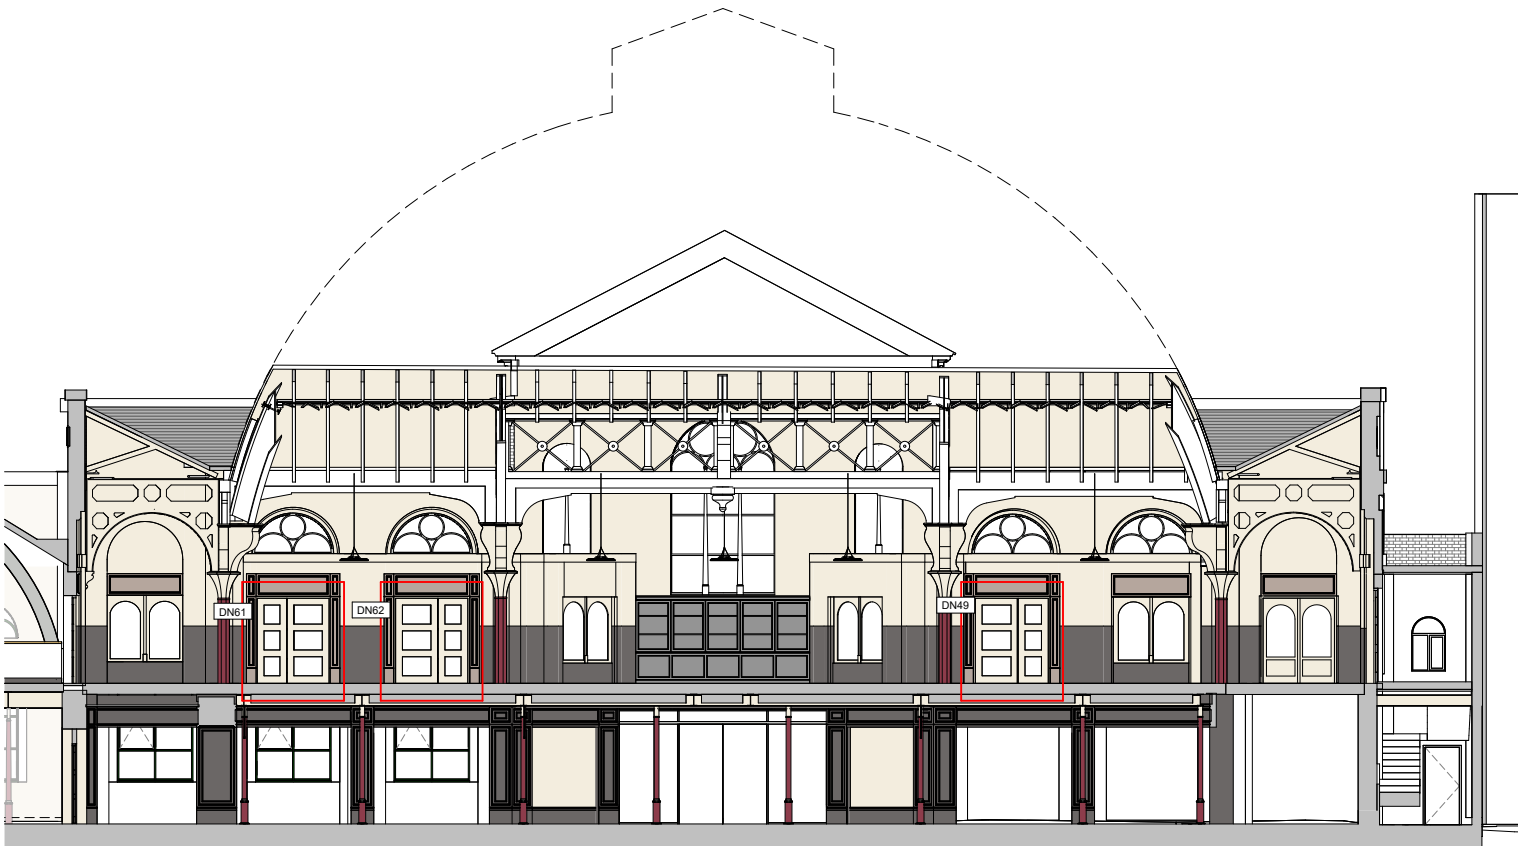
Fig. 14: New elevation showing replacement internal doors to southern balcony

Internal elevations showing the asymmetric replacement doors shown to all existing Make & Trade units at the balcony level.
